Management plan of shipwreck site Burgzand Noord 10

NISA 2004

0. Administrative details

Toponymy: Burgzand Noord 10 (BZN10)

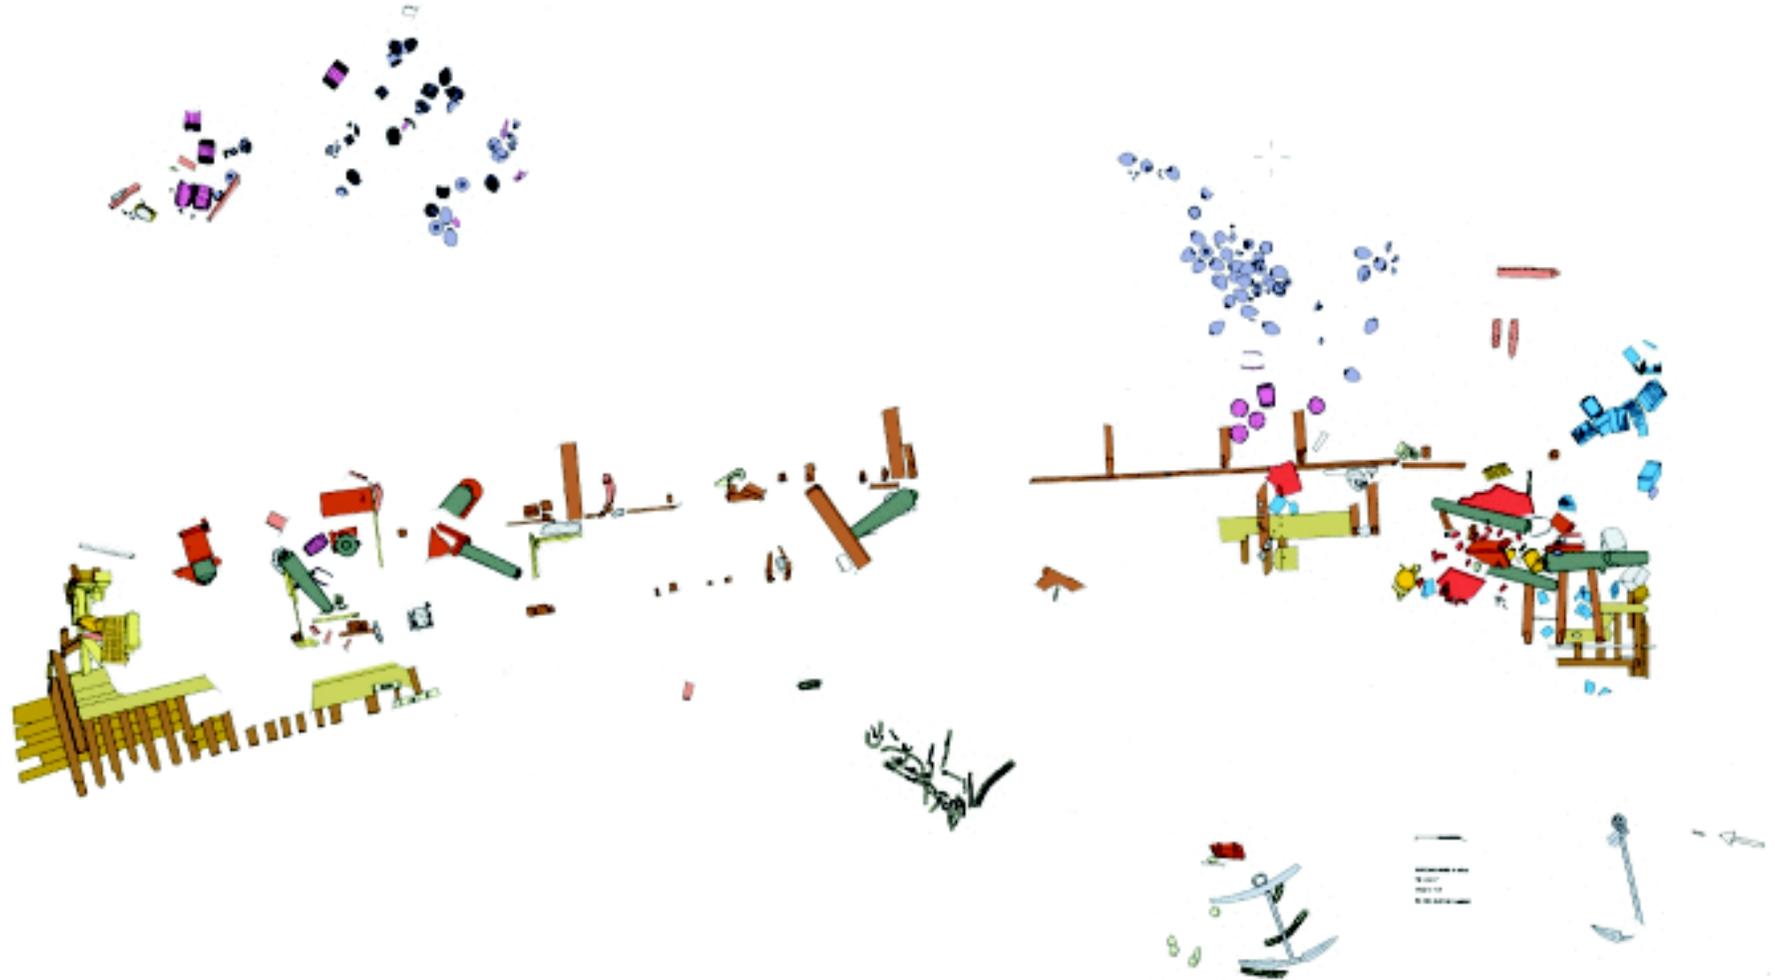
Site plan BZN 10

It consists of everything sticking out of the seabed in 2000.

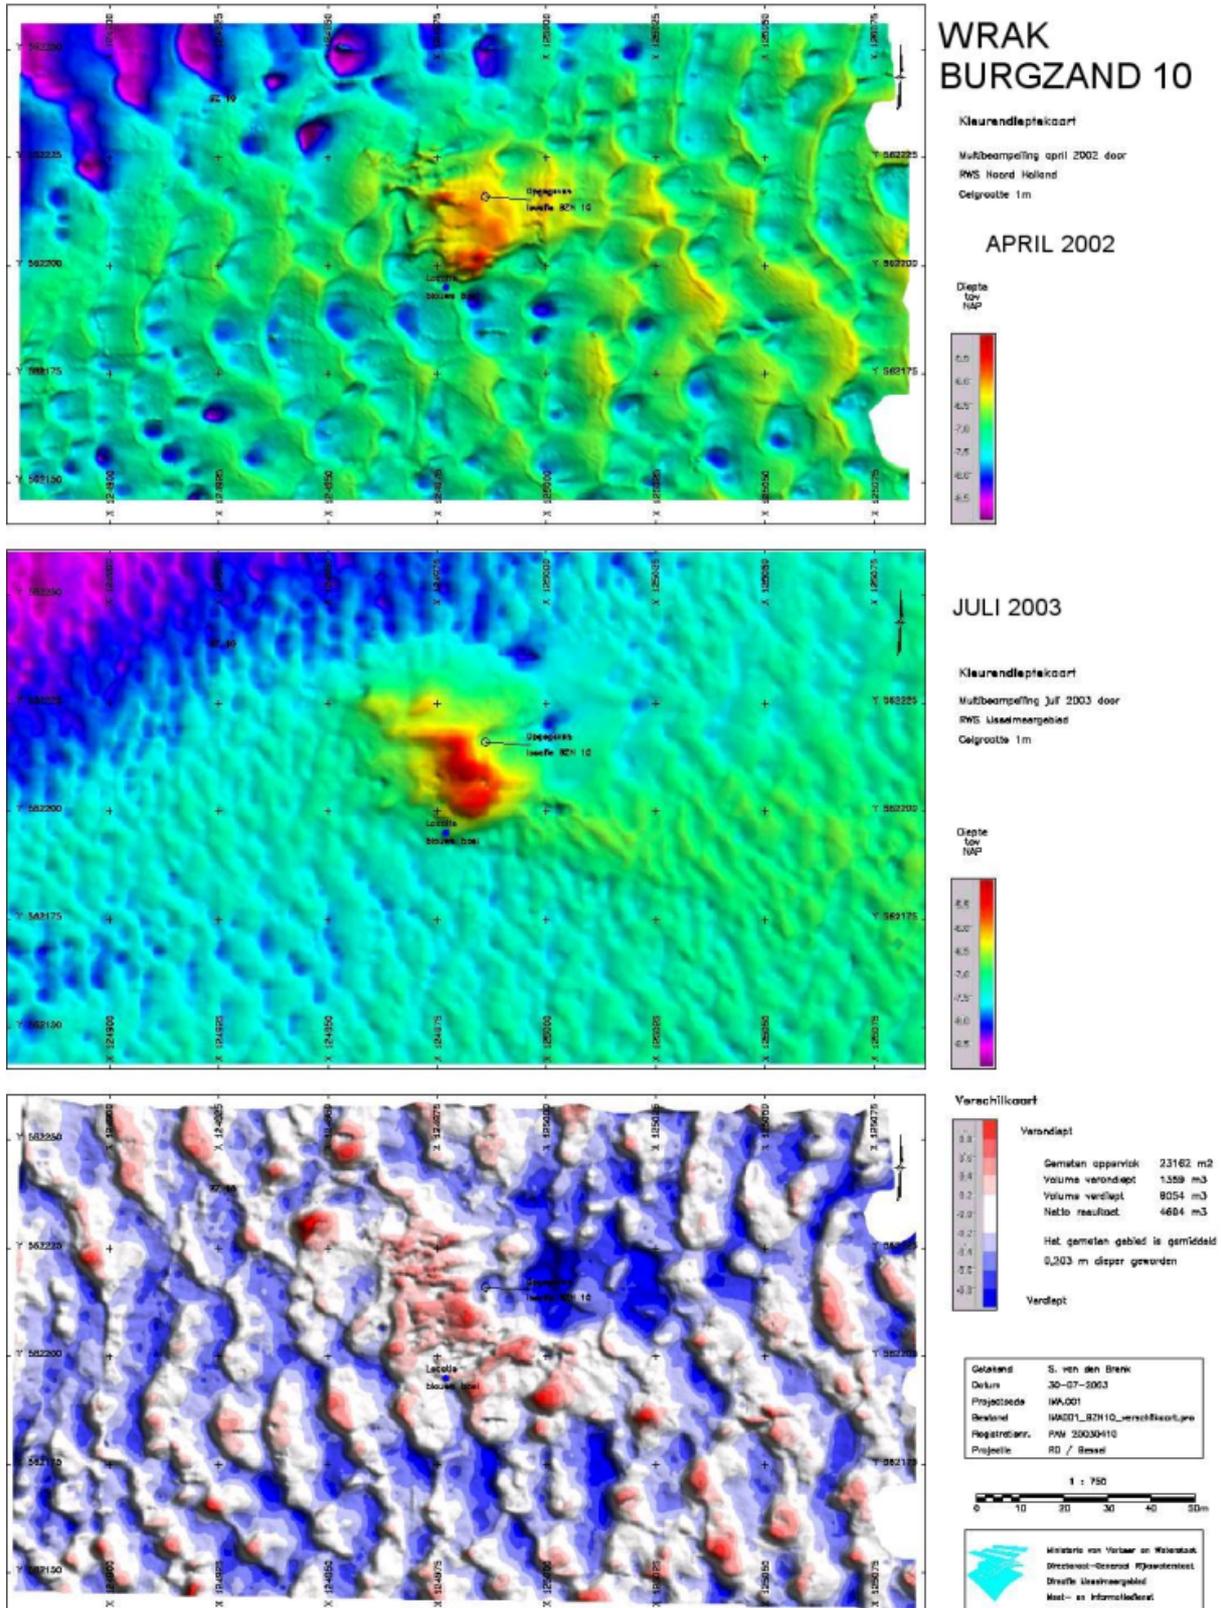
Appendix 7

Monitoring with multibeam sonar on the BZN 10 wrecksite
