## Management plan of the wreck of Vrouw Maria

The Department of Archaeology / Section for Maritime Archaeology 2004

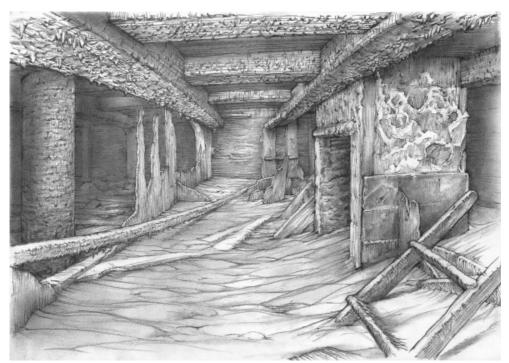
The iron parts that are visible are mainly bolts that are corroded. There is very little metallic iron left in the bolts and it is likely that the bolts are not good fasteners any more. The ship's oven, which is made of brick, seems to be intact.

2C. The interior of the bow of Vrouw Maria. To the right there is the ship's oven. Drawn by Tiina Miettinen, The National Board of Antiquities, 2004.

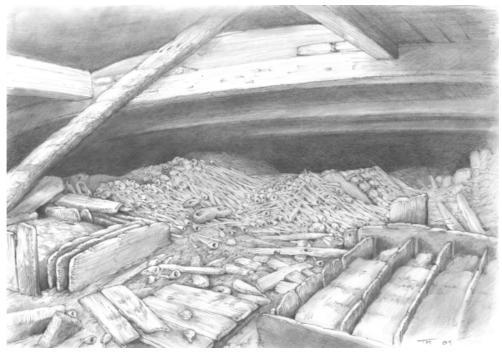
The zinc has worn well except for the top layer. The clay pipes are well preserved.

2 D. The Vrouw Maria cargo hold with clay pipes, zinc ingots and packing cases. Drawn by Tiina Miettinen, The National Board of Antiquities, 2001.

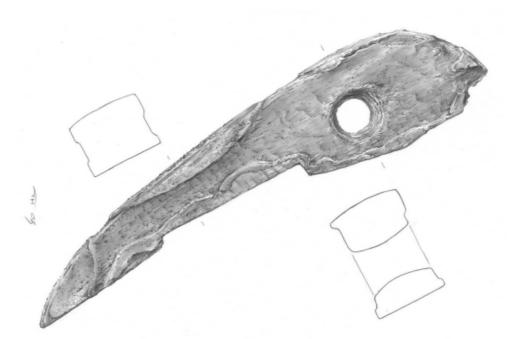
The completeness of the wreck parts is evaluated visually. So far there is only one wreck part that has been raised: the tack block. The parts of the wreck are mostly whole. The rigging has fallen to pieces but the breaking has taken place in the course of years, when the fasteners have decayed, and the loose parts are on the deck and on the sea bottom on the starboard side of the wreck. For example the deck cabin has collapsed when parts of the rigging have fallen on it. Smaller parts have loosened at the joints when falling and for example the handrail is in many pieces on the deck.

The wood of the wreck is in good condition. For example, the tack block that was raised is hard oak. See chapter 2.3.3.1.

A tack block (SMM 82002:3). Drawn by Tiina Miettinen, The National Board of Antiquities, 2003.
