Newsletter ^{1/2003}

A shipwreck research project funded by the European Union Culture 2000 Programme

Theme: **Vrouw Maria** contents

Introduction of the Wreck of *Vrouw Maria*

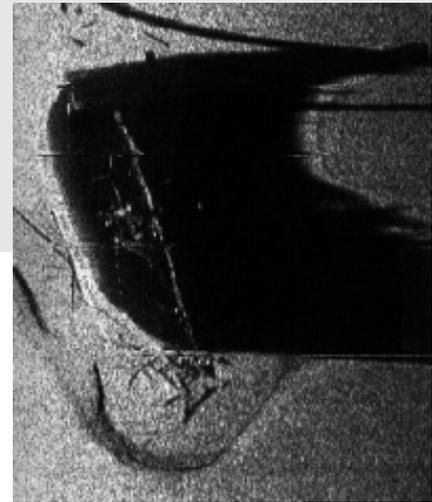
Fig. 1. A side scan sonar image of the wreck of *Vrouw Maria*. Image: The Finnish Defense Forces.

The wreck appears at sailing position in a small deep that is surrounded by shallows. The wreck is approximately 26 meters long and 7 meters wide. It lies on its keel on the bottom of the sea and leans on its starboard side. The masts, which are standing up, rise to a depth of 22 - 24 meters. The masts are made of three parts, and the upper parts have fallen down on the starboard side of the wreck on the bottom of the sea.

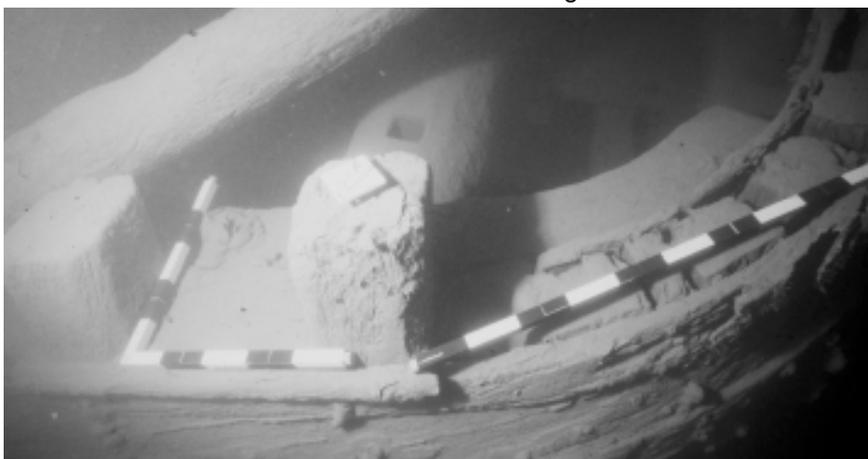
Fig. 2. The reference point No. 1 on top of a bollard. Photo: Jouni Polkko.

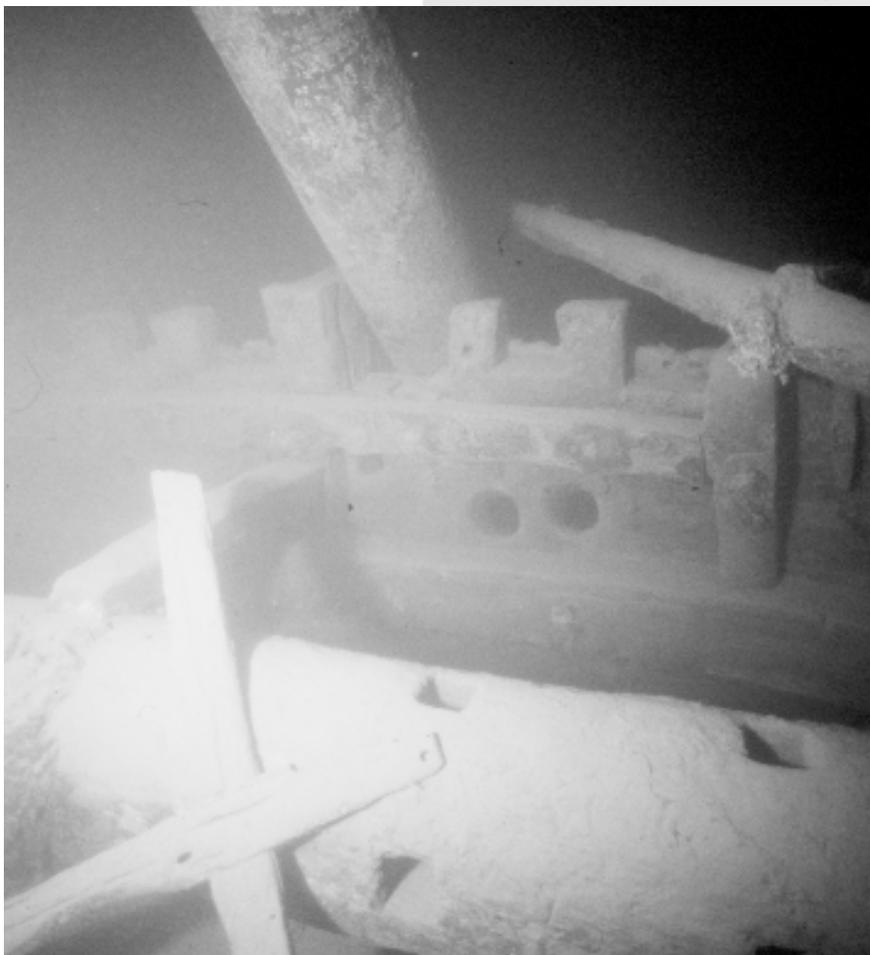
Fig. 3. Above the windlass can be seen the bowsprit, which today is leaning against the bow next to the stempost. Photo: Jouni Polkko.

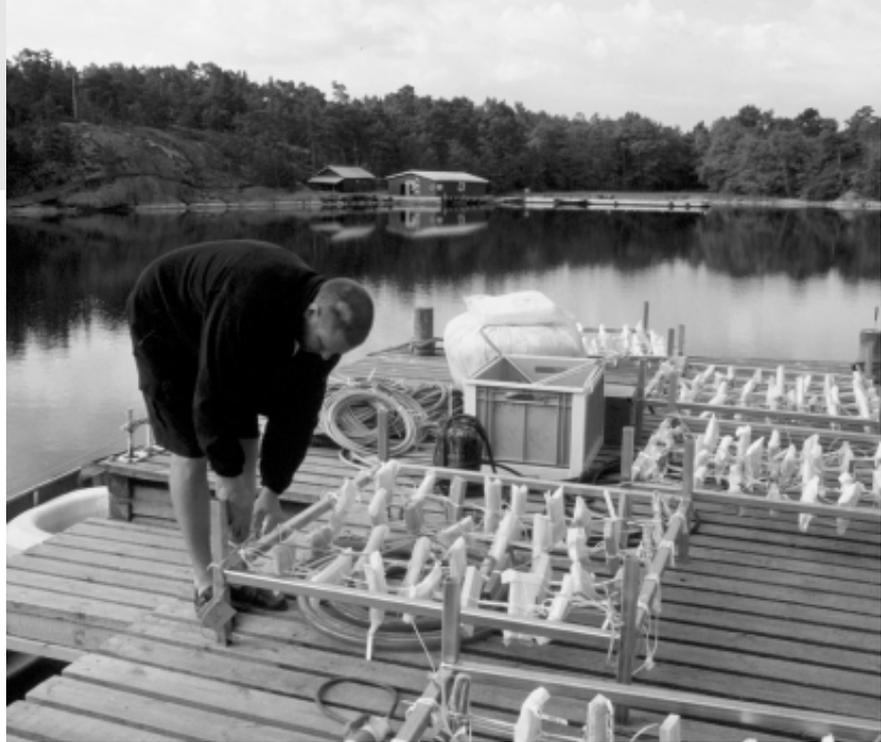
Fig. 4. Woodsamples are being prepared at the pier of Bodö. Photo: Ulla Klemelä.

The deterioration of wood is investigated by the help of wooden samples. In June 2002, five metal grids with 33 samples each were placed at the site. The samples help us to determine the types of wood boring animals, fungus and bacteria that decompose waterlogged wood. In addition, the aim is to find out how well the wood wears and what are the chemical changes that take place in it. A part of the samples are wrapped within filter-textile of different grades. The aim is to get information about the way the textile protects wooden wrecks from mechanical wear and different wood boring organisms that gnaw wood. The first set of samples was raised from the site and sent to the Mary Rose Archaeological

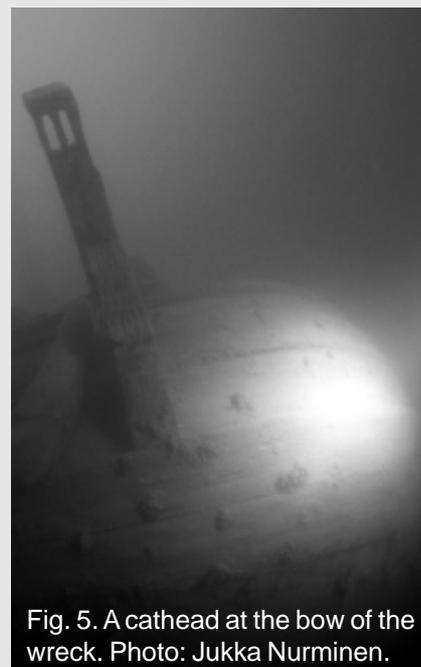
Fig. 5. A cathead at the bow of the wreck. Photo: Jukka Nurminen.

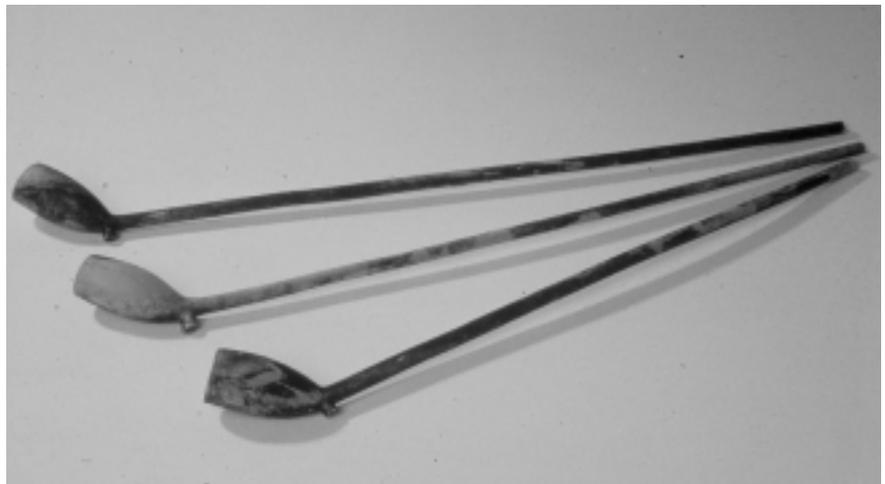
Fig. 2. The three clay pipes raised from the Vrouw Maria. Photo: The Maritime Museum of Finland

All three pipes are unbroken except for small pieces, which are missing at the end of the stems (the mouthpieces) of the same. Of the three pipes two have a mark constituted by a crowned B, and one a mark in the shape of a birdcage. The clay is discoloured in all of the pipes, especially in the pipes marked with a crowned B. The dark brownish colour is due to corrosion residues.
