A shipwreck research project funded by the European Union Culture 2000 Programme

Theme: The Darss Cog Site

The Darss Cog-site and its research history

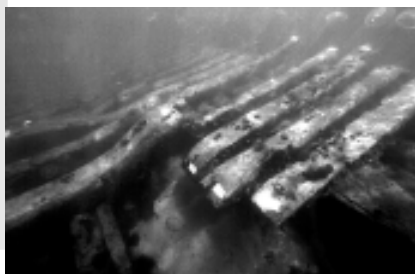
Hull of the Poel cog from 1354, a Baltic ship with a cargo capacity of more than 200 tons. Photographer: Klaus Andrews, Hamburg.

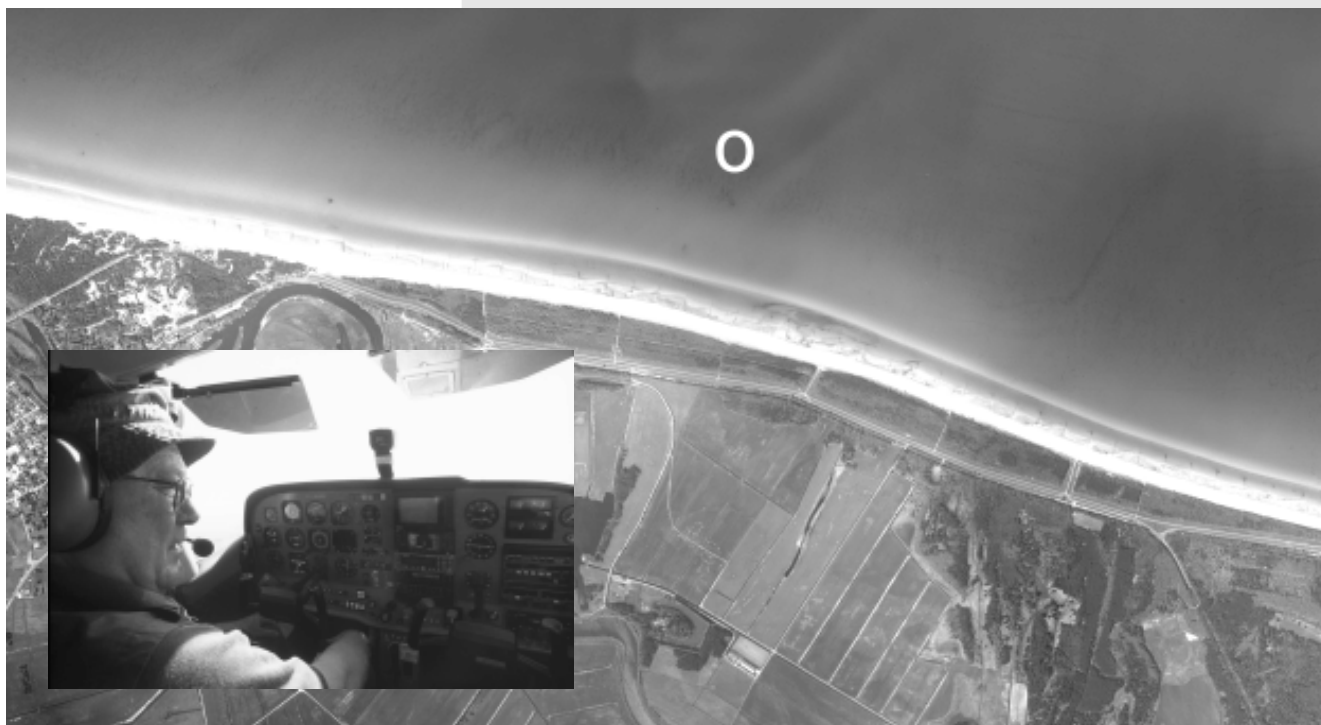
Aerial photograph of the Darss cog site off the old mouth of the river *Prerowstrom* and the aerial photographer Otto Braasch in his Cessna. Photographer: STAUN, Rostock and Roland Obst, Erfurt.

The Darss Cog sank in the 14th century in the old mouth of the River Prerowstrom, the course of which is still recognizable on the seabed.

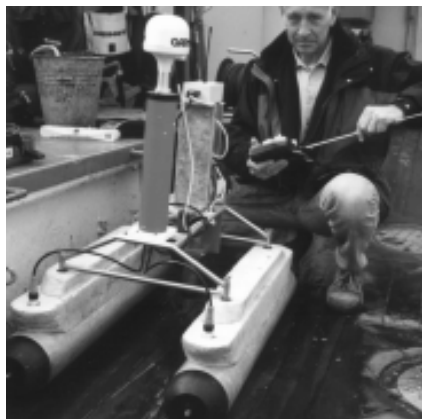
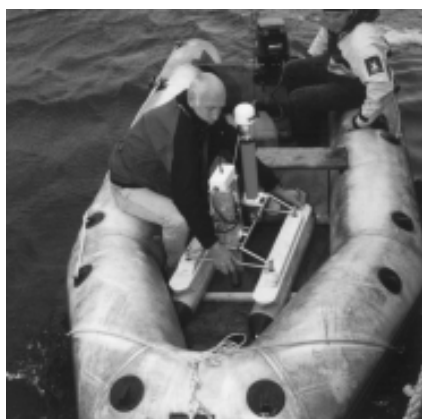
Sediment sonar reading visualizing the conditions in a depth of 1.2 m in the ground. Wreck, cargo and ballast are shown for the higher density in cyan, magenta, red and black whereas the sediment is depicted in yellow and green. Recording: Klaus Storch, Jena.

A sediment sonar survey is useful for planning excavations because the extent of a site can be displayed in 3D. A computer model has enabled us to graphically simulate excavation before fieldwork. The sediment sonar

penetration is limited if the sub-strata is composed of compressed sand, or an accumulation of stones or sediment containing gas. In these a high density or gaseous conditions georadar is required rather than hydro acoustic sonar.

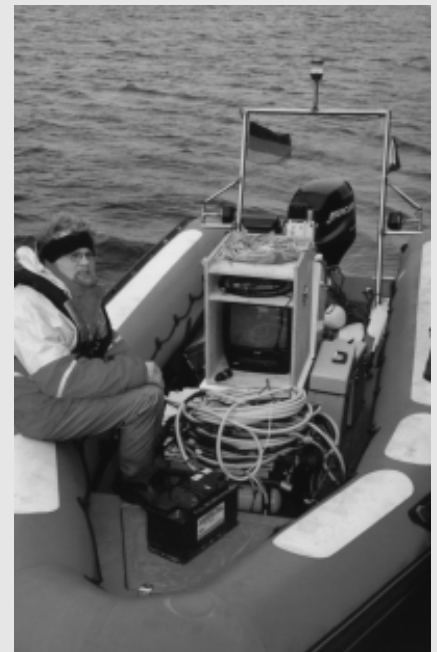
Preparing the georadar. The scuba radar antenna with the video camera as well as a screen for observation can be recognized. Photographer: Matthias Orgeldinger, Nürnberg.

- The recordings of the longitudinal profile shows circa 18 m of the extant starboard side and a width section of circa 6 - 8 m.
- Within the ship's shell a number of single objects can be recognized which belong to the ballast, the cargo or the collapsed parts of the ship.
- Several single objects were located in the southern section of the wreck.
- In the western external section a few unidentified objects have been found.
- Few single objects are east of the wreck.
- Objects are concentrated to the north and south of the wreck.

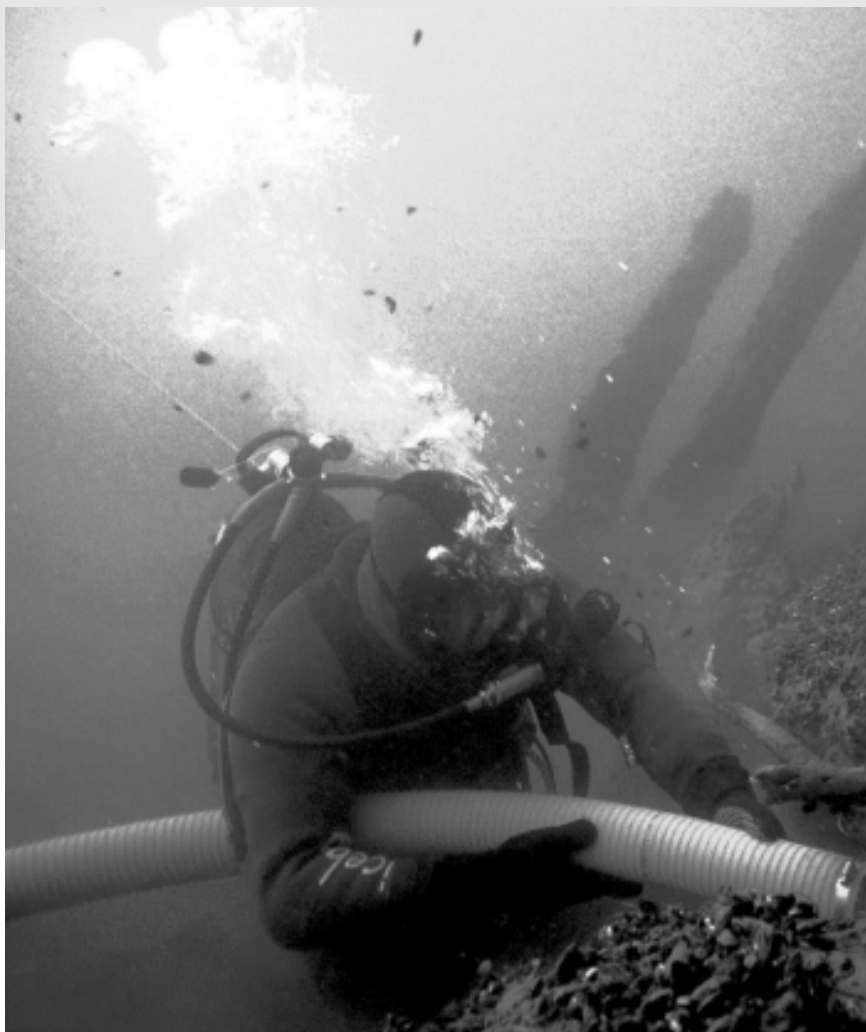
Uncovering the wreck by water dredging.
Photographer: Roland Obst, Erfurt.

Excavating the wreck was carried out with suction-pipes of only 12 cm diameter. This small diameter was to minimize possible damage to the hull or items of ship's equipment. The removed sediments were sieved for small finds. Fencing nets around the site gave some protection to exposed parts

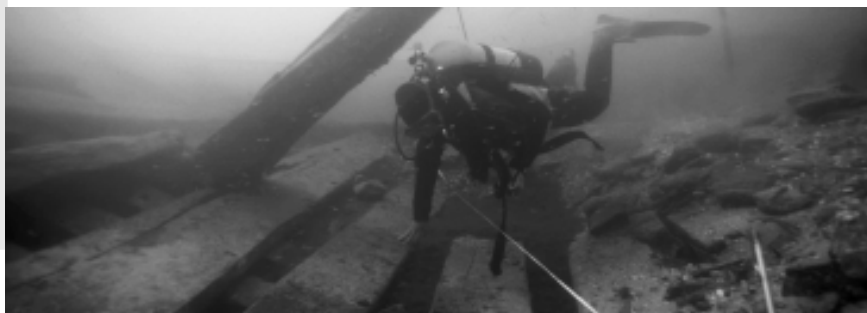
The third crossbeam sits in front of the mast step and supports the mast. Beneath the crossbeams one can see the stringers and ceiling planks. Photographer: Roland Obst, Erfurt.

The first five floor timbers are made of v-shaped angled wood and are supported by beams that run from port to starboard. This possibly created a small cargo area because it is where the sulphur barrel, reindeer antler, two pairs of shoes, ropes and textiles were found. The keelson starts at the fifth floor timber and has a maximum width of 70 cm at the thickened section of the mast step. The mast step itself is 70 cm long and 30 cm wide. An incorporated ledge in the mast step served for wedging the mast tight. Three uncovered crossbeams penetrate the hull at the twelfth and thirteenth plank strake. From the upper side knees provide for cross stability and deck fastening. The deck edge is still to be found at the bulwark. A circular and a square opening in the hull were probably scuppers to allow water to clear from the deck. The ship's interior is lined with ceiling planks, which are either nailed to the floor timbers or in case of pine planks more loosely attached. Stringers are attached to the sideboards to increase the cross stability. Treenails of 30 to 45 cm diameter were used to fasten the frames, keelson, knees, ceiling planks and stringers.

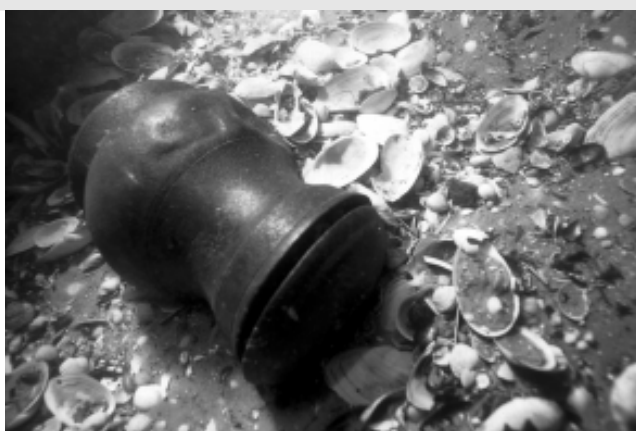
A pewter Hanse can with the depiction of the crucifixion on its lid. photograph: Frank Kleeblatt, Dessau.

found in the ship's interior, which is common in the area and known as a hanseatic can. A depiction of the crucifixion is shown on the lid. The handle carries the inscription 'AVE REG(ina)' and an owner's monogram. Close to the hanseatic can, a flat pewter bottle with a different owner's mark appeared. A leather stopper was still attached to the bottleneck.

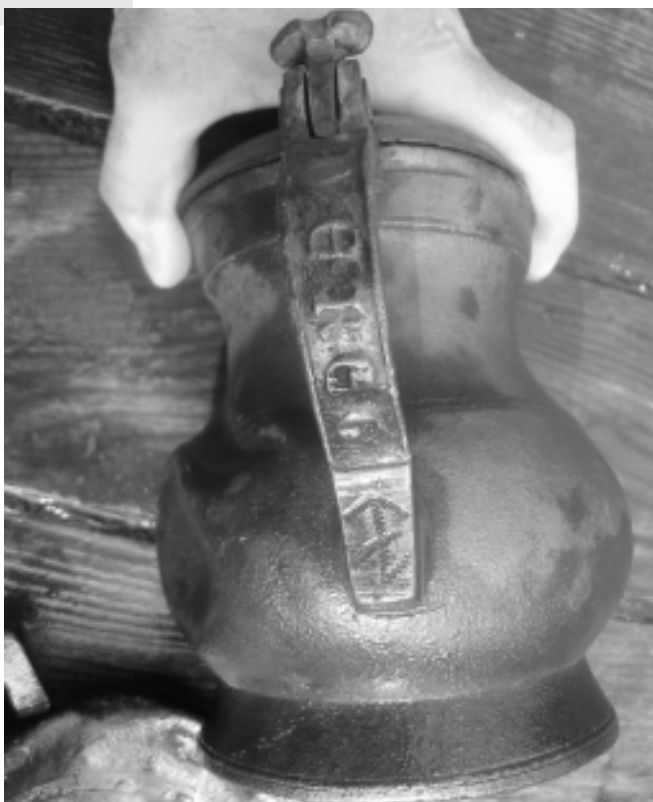
The handle of the *Hanseatic can* carries the inscription 'AVE REG(ina)'. Photographer: Frank Kleeblatt, Dessau.

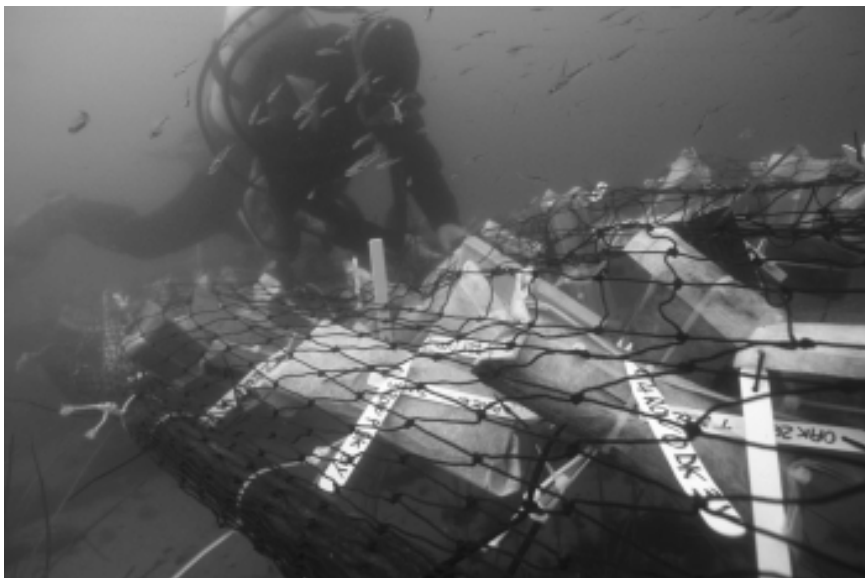
The destructive effect of *Teredo navalis* is shown on this sawn-open plank.
Photographer: Matthias Orgeldinger, Nürnberg.

the last century. In the Netherlands the mollusc destroyed lock gates as early as 1731. In the late summer of 1993 an infestation was recognized on wooden breakwater structures in the Darss – Zingst – Hiddensee area. This is the greatest mass occurrence of this species in the area since an outbreak in 1932/34. It is estimated that *Teredo navalis* has damaged 50% of all breakwater structures on the coast of Mecklenburg-Vorpommern. Financially it has been estimated that to repair the damage would cost about 13 million*. More crucially from our perspective *Teredo navalis* was also observed on most exposed wooden shipwreck-sites in the area. A monitoring programme on the problem initiated by the State Authority for Environment and Nature shows that the shipworm has adapted to the conditions in the Baltic and the concern is that the threat is not going to disappear quickly.

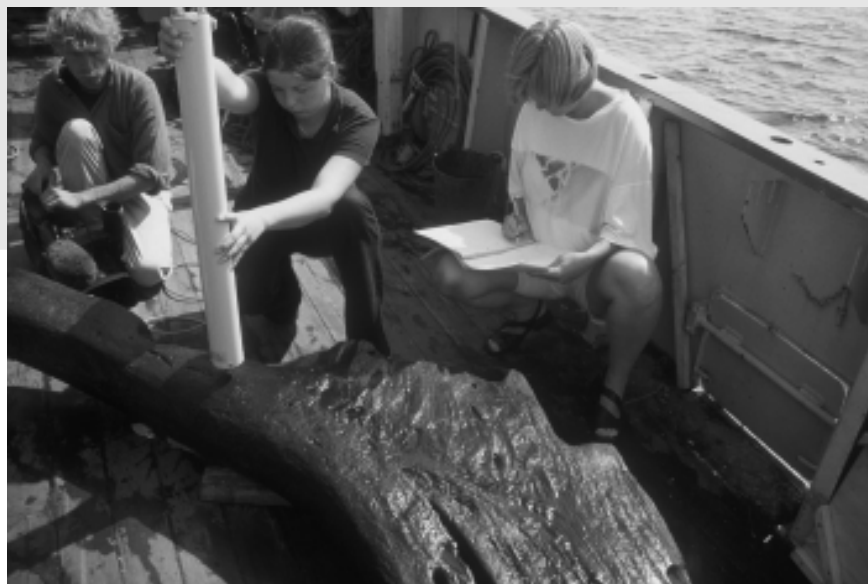
Examining the deck knee with a device measuring the bore resistance.
Photographer: Roland Obst, Erfurt.

Archaeological waterlogged wood from Mecklenburg-Pomerania was drill resistance tested in the summer term 2002. This research was in preparation for a diploma dissertation for the Department of Civil and Structural Engineering, University of Wismar. A starboard knee from the Darss Cog was one of the pieces of archaeological wood tested. The objective of this research was to validate the methodology as a degradation measure. Drill resistance testing is used for the investigation of internal decay damage in timber. The drilling device measures the rotation resistance of a thin needle. The head of the needle is only 3 mm diameter and can be regarded as quasi-non-destructive. Drilling was done using a RESISTOGRAPH 3450 of Rinntech (Heidelberg). The starboard knee to be investigated was recovered from a depth of about 6 m. The test was done immediately after recovery, on board the dive-ship. The knee was 2.5 m long, 1.2 m wide and

16 to 22 cm high. There was little visible external damage caused by shipworm, the state of preservation was good and the wood was only degraded superficially. Nine drill tests were carried out, well distributed over the starboard knee. Degraded wood at the surface of the wood could be identified in the drilling profile by a lower drilling resistance compared to

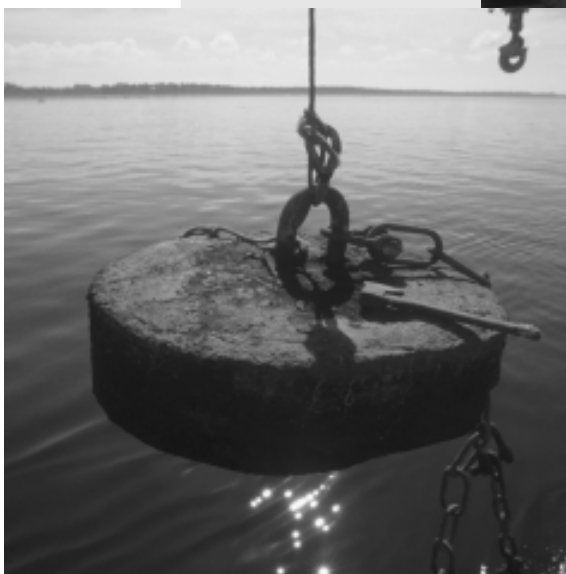
Marking the wreck site and sinking of an anchor weight for the base ship *Seefuchs*. Photographer: Roland Obst, Erfurt.

the research-strategy. The dive ship *Seefuchs* was moored 100 m from the wreck to avoid damage. The underwater excavation and recording was carried out using small working boats, which were moored with ground weights 10 m away from the wreck. After recording the ships timbers, the hull was immediately refilled with sediment and covered with a fleece material and sandbags. In addition, the exposed parts of the ship
